# 13 PROBLEMS, COMPLICATIONS AND HOW TO GET OUT OF TROUBLE

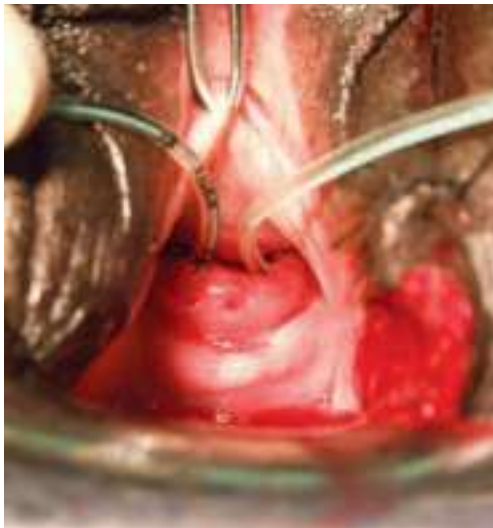
**Figure 13.1**  
Nasogastric feeding tubes used as ureteric catheters.

Ureteric catheters are often difficult to obtain and many surgeons have to operate without them. If this is the case, the important thing to do is identify the ureter and if it is possible to hold a ureteric probe in the ureter while doing the dissection and suturing, have your assistant hold the probe tightly. I know of at least one surgeon who lost a ureteric probe in the ureter and couldn't get it out. An alternative to a ureteric catheter is an infant nasogastric feeding tube. (Figure 13.1) These are thin and soft and often difficult to insert. You will need to thread them through the urethra first and then make sure they are secured in the ureter with a stitch, as they easily fall out.

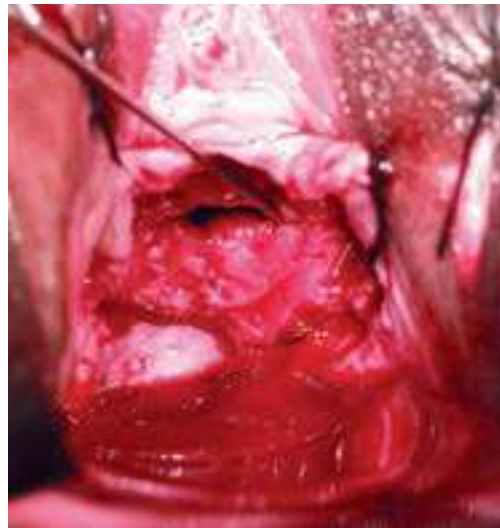
**Figure 13.2**  
A ureter has been identified with a probe, but there was nothing to catheterise it with. The sutures were placed with the probe carefully held in the ureter. Urine was still coming when the probe was removed after the corner was secured.

If a ureter is identified as being at risk, it may be possible to protect it without the use of a catheter, but be careful not to drop the probe. (Figure 13.2)

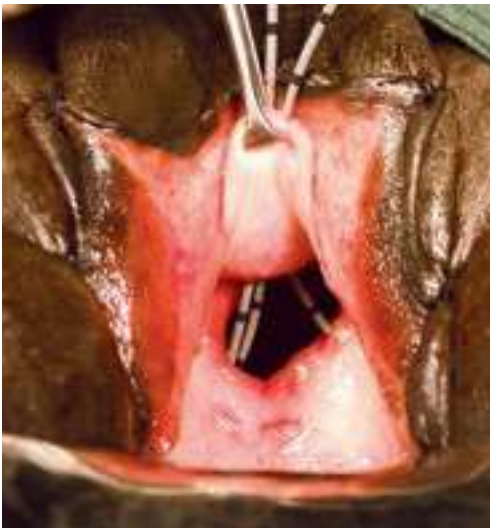
**Figure 13.3**  
A double ureter

A double ureter is not that uncommon. (Figure 13.3) I was once caught with double ureters on both sides, so a duplex duplex system. The patient needed four ureters catheterised!

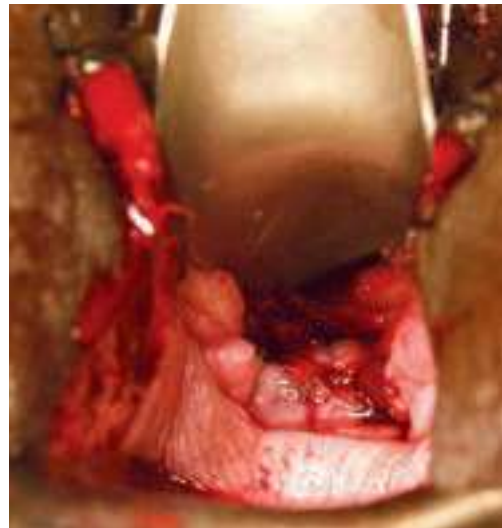
**Figure 13.4**  
A high fistula running up a split uterus. A deliberate decision was made to repair the bladder without catheterising the ureters as it was not technically possible. The ureters ended up being ligated and needed to be implanted abdominally.

A patient presented with a recurrent high intra-cervical fistula visible through a split open cervix. The defect extended below the level of the cervix and was judged unsuitable for a trans-vesical repair. (Figure 13.4) The ureters were seen squirting on the edge of the ragged defect, but after 45 minutes could not be catheterised. The bladder was mobilised off the cervix remnant and the uterus, and the defect was closed with a running suture. The ureters were clearly at risk, but there seemed to be no other option. The dye test was negative, but the patient produced no urine on the table. The abdomen was opened, and both dilated ureters were divided and anastomosed to the bladder. The patient had made a complete recovery when she was seen 3 months later.
